# Refurbishment of D1 and D2 Distillation Columns

PPG HI-TEMP 1027™ chosen to provide high-temperature protection

Refurbishment of distillation columns

North Taranaki, New Zealand

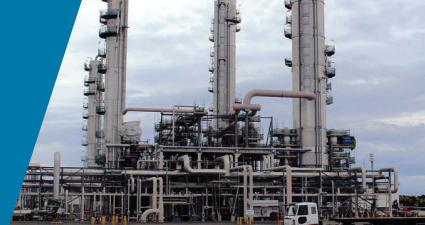
The columns are 26 years old with the original inorganic zinc silicate still adhering on the majority of the steel substrate. In addition, there was a variation in the operating temperature of the steel substrate as the contractors progressed down the column.

The methodology was to remove the existing inorganic zinc silicate by abrasive blasting (non-metallic) and apply the PPG HI-TEMP 1027 coating while the distillation vessel was still in operation.

- PPG HI-TEMP 1027 at 125 µm
- PPG HI-TEMP 1027 at 125 µm

The coatings were applied insitu by TBS Coatings Ltd. under various weather conditions in the middle of winter between June and September 2016. Most of the application was hot applied with the applicators using the “multiple mist coat application method” to achieve the required DFT. This method used by TBS Coatings Ltd. reduces the possibility of blisters appearing when the PPG HI-TEMP 1027 coating is applied too heavily.
