SIGMAPRIME® 700

Outstanding ballast tank protection for long-lasting performance

Case study

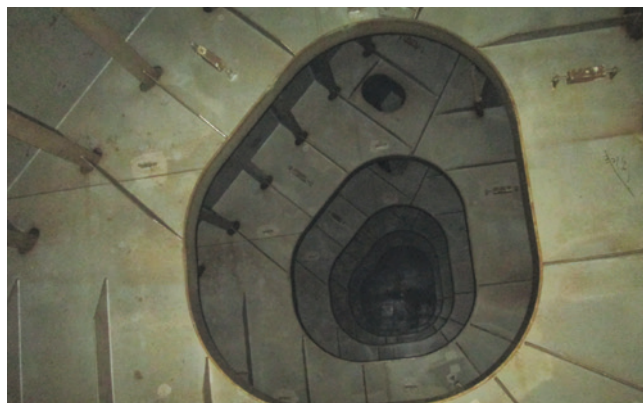
Top image: The water ballast tank area is vast and complex making access and repairs very difficult. The SIGMAPRIME coating is the optimal solution for any water ballast tank project

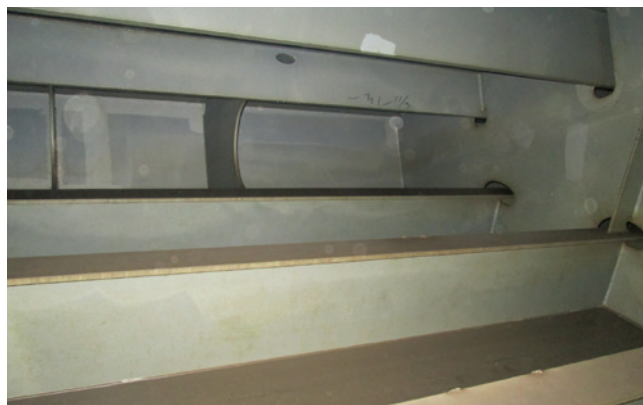
Middle image: SIGMAPRIME 700 has been designed for optimal edge protection: no corrosion has been found

After 5 years in service, the performance of the SIGMAPRIME 700 coating is outstanding and its appearance is as good as new. On inspection, there was no need for any repair in the water ballast tank area to the satisfaction of Mr. D. E. Kourouklis, Director Marine Operations of Chandris Hellas who stated, "With less than 0.1% damage, the coating is performing very well, as expected from a SIGMAPRIME product."

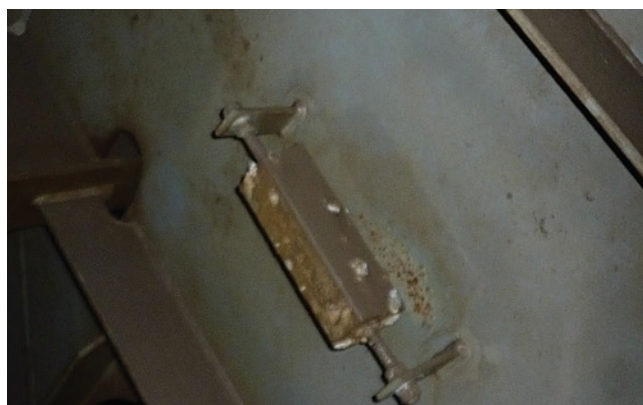
Bottom image: The sacrificial zinc anode is as good as new as a result of the outstanding anti-corrosive properties of the SIGMAPRIME coating
