SIGMASHIELD™ 1200

The ultimate protection for vessels operating in extreme ice-going conditions

Case study

The SEAGARD Container vessel operates mainly in the Gulf of Finland, Baltic Sea and North Sea

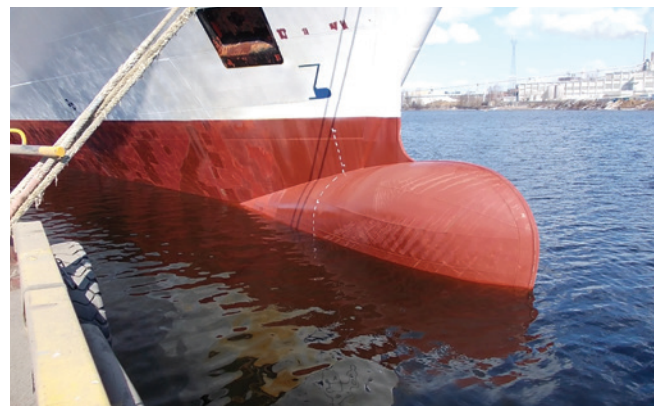
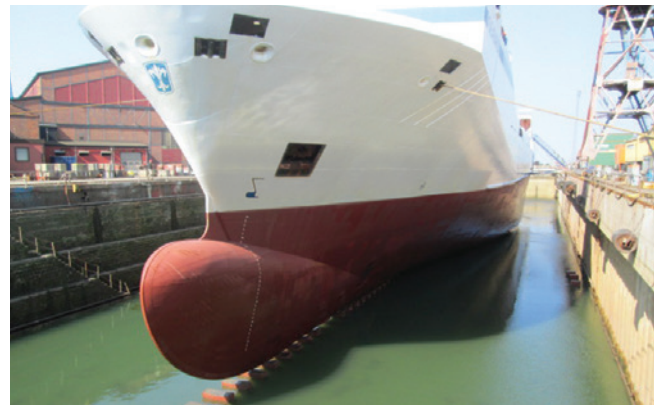
Image: After two winters operating in heavy ice conditions the underwater hull of the SEAGARD is still in perfect condition.

Following close inspection in dry dock, the SEAGARD's underwater hull is still in perfect condition, which is an excellent result for a vessel operating in harsh conditions through ice.

Mathias Sundberg, Technical Superintendent of Bore Ltd. stated: "On inspection, after two winters operating in heavy ice conditions, the underwater hull is still in perfect condition. The SIGMASHIELD 1200 coating is performing very well, as expected from a PPG product."
